Manhole Inspection Summary

Manhole # S19GG_023MH

Insp Date: **6/14/07 8:39 AM**

Location Address: **1601 BAKER ST**

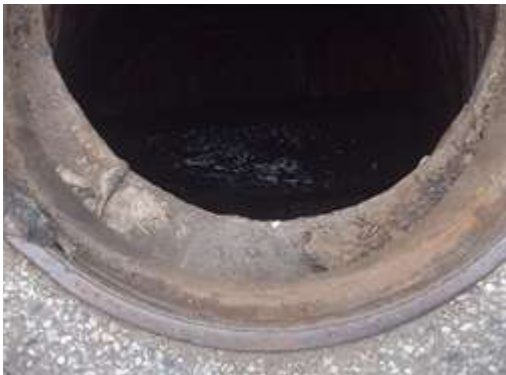
Defect 1

Frame Offset: **4** (in.) Condition: ☒ Sound ☐ Cracked ☐ Leaks

FRAME OFFSET

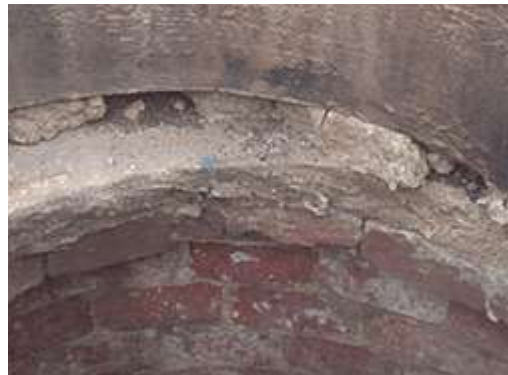
Defect 3

Chimney / Frame Adjustment ☒ Exists Material: **Concrete** ☐ Parged Height: **3** (in.)

Condition: ☐ Sound ☐ Cracked ☐ Root Intrusion ☐ Loose Brick ☒ **Deteriorated**

DETERIORATION OF CHIMNEY

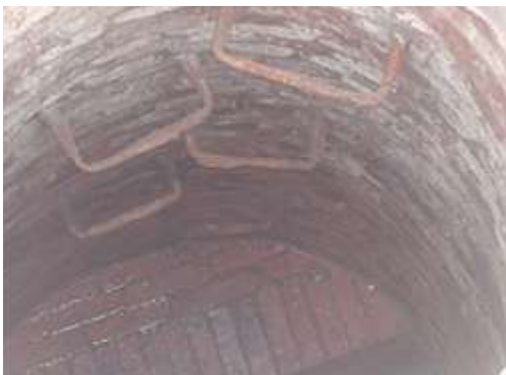
Defect 2

Steps Count: **5** Missing: **0** ☒ **Corroded**

CORRODED STEPS

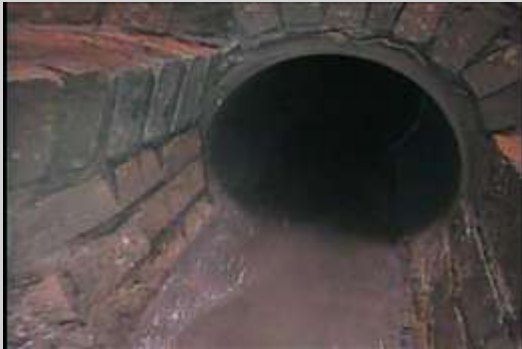
12 O'Clock Outflow

Pipe Height: **15.6** (in.) Rod and Bar (Angled)
Pipe Material: **Clay** ☐ Pipe Lined
Invert Depth: **10.33** (ft.) Flow Characteristics: **Slow**
Deposits: ☒ None ☐ Mud ☐ Sludge ☐ Debris ☐ Grease
Silt Depth: (in.) Deposits Extent:
Infiltration: **None** Pipe Seal Cond: **Sound**

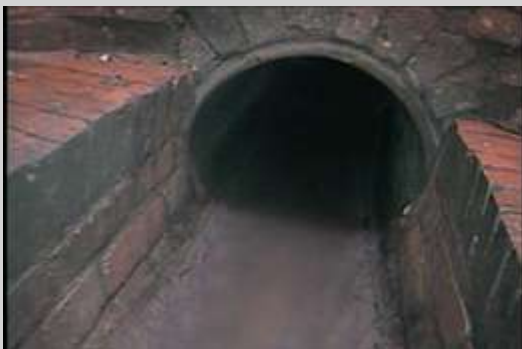
6 O'Clock Inflow

Pipe Height: **15.6** (in.) Rod and Bar (Angled)
Pipe Material: **Clay** ☐ Pipe Lined
Invert Depth: **10.28** (ft.) Flow Characteristics: **Slow**
Deposits: ☒ None ☐ Mud ☐ Sludge ☐ Debris ☐ Grease
Silt Depth: (in.) Deposits Extent:
Infiltration: **None** Pipe Seal Cond: **Sound**

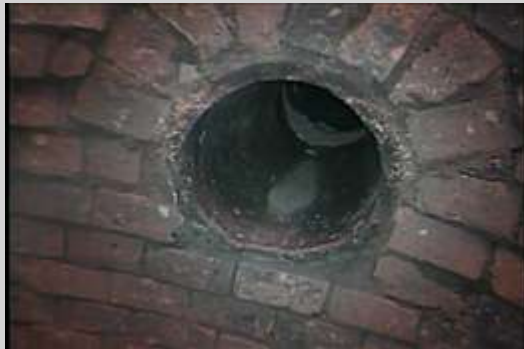
9 O'Clock Inflow

Pipe Height: **8.4** (in.) Rod and Bar (Angled)

Infiltration: **None** Pipe Seal Cond: **Sound**

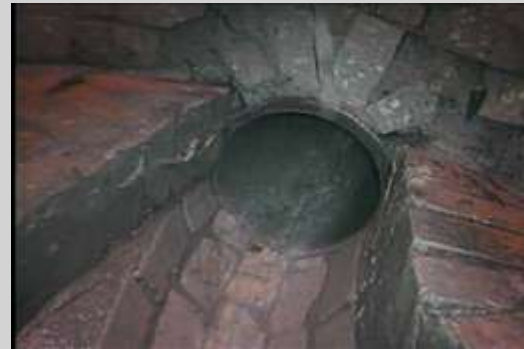
Drop In @ 9 O'Clock

Drop: **Outside** Rod and Bar

Angled: **Yes** Reading: **8.64** (ft.)

Inv Depth: **9.64** (ft.)

Drop Condition: **Open**
